Maryland Historical Trust
State Historic Sites Inventory Form

Survey No. B-4333

112 N. Howard Street

Howard Street Jewelers

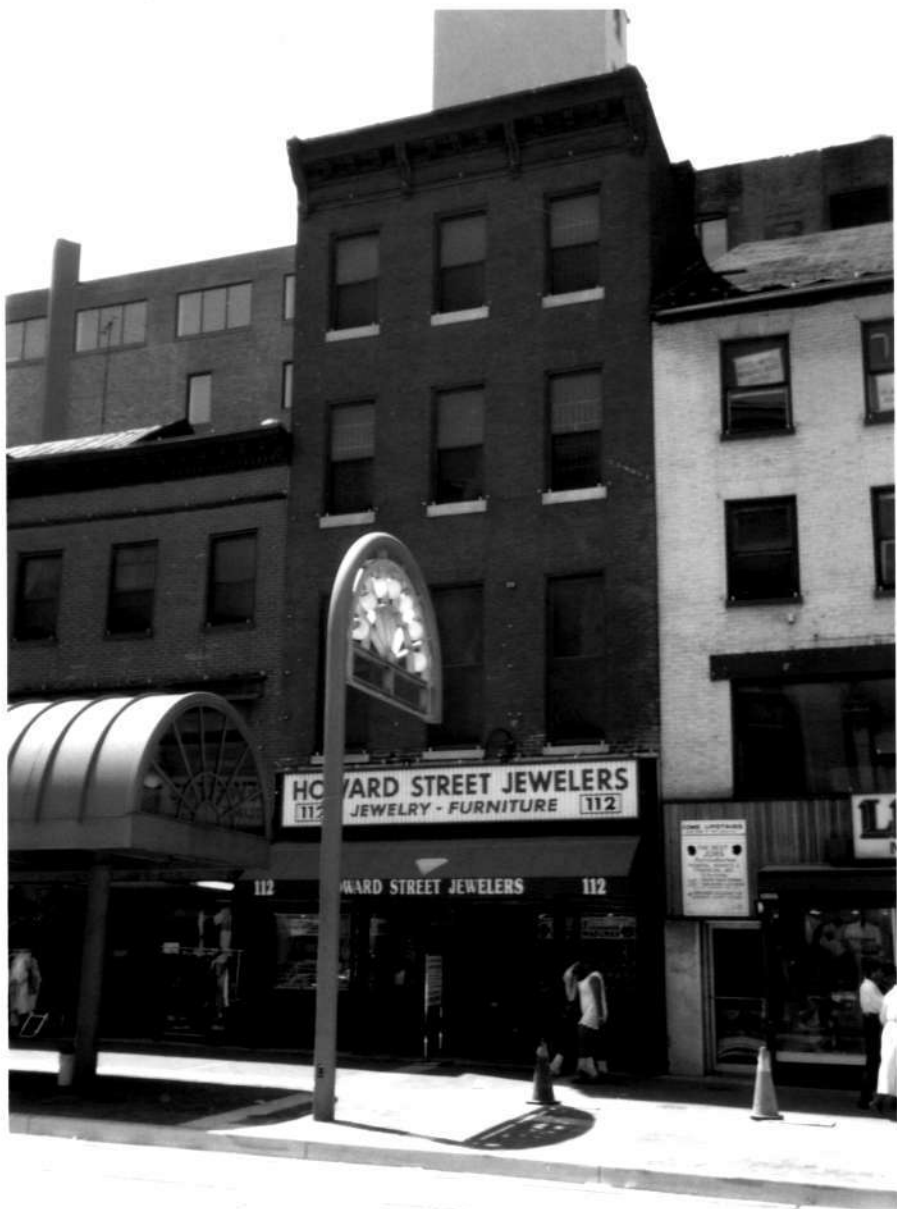
1/3

Facade, east elevation

This circa 1850-1860 commercial building is four stories high and three bays wide. The brick stretcher bond building faces east on N. Howard and abuts two partywall structures. The facade originally was enriched only by the decreasing size of the windows as the stories rise, and by the cornice and stone sills that contrast with the pressed brick with tight mortar joints. A circa 1940s storefront on the first story presents an embellished facade. The street frontage is 20'6" and the depth is 64'6".

The first story was substantially altered in the 1930s-1940s. The middle bay is deeply recessed and contains the glazed door and transom. Four steel posts positioned across the facade support the upper stories. Asymmetrical display cases set on recessed plinths flank the entrance. The foundations of the display cases are covered with ruby vitrolite panels. The display case to the south is set on a rectangular plinth; the projecting display case has rounded corners. The display case to the north is set on a four-sided, bowed plinth; the projecting display case follows the same four-sided bow. The glass panes are set in molded metal surrounds. A fabric awning is suspended over the first story.

The second, third, and fourth stories are stacked versions of one another. The height of the windows decreases as the building rises. The second story windows are extremely elongated. Three windows with brick splayed jack arches and stone sill are evenly spaced on each story.

The projecting cornice has four evenly spaced scrolled L-brackets with shell pendants that divide the cornice into bays. Smaller scrolled brackets are spaced between the large L-brackets. Two stringcourses of raised molding run between the L-brackets.

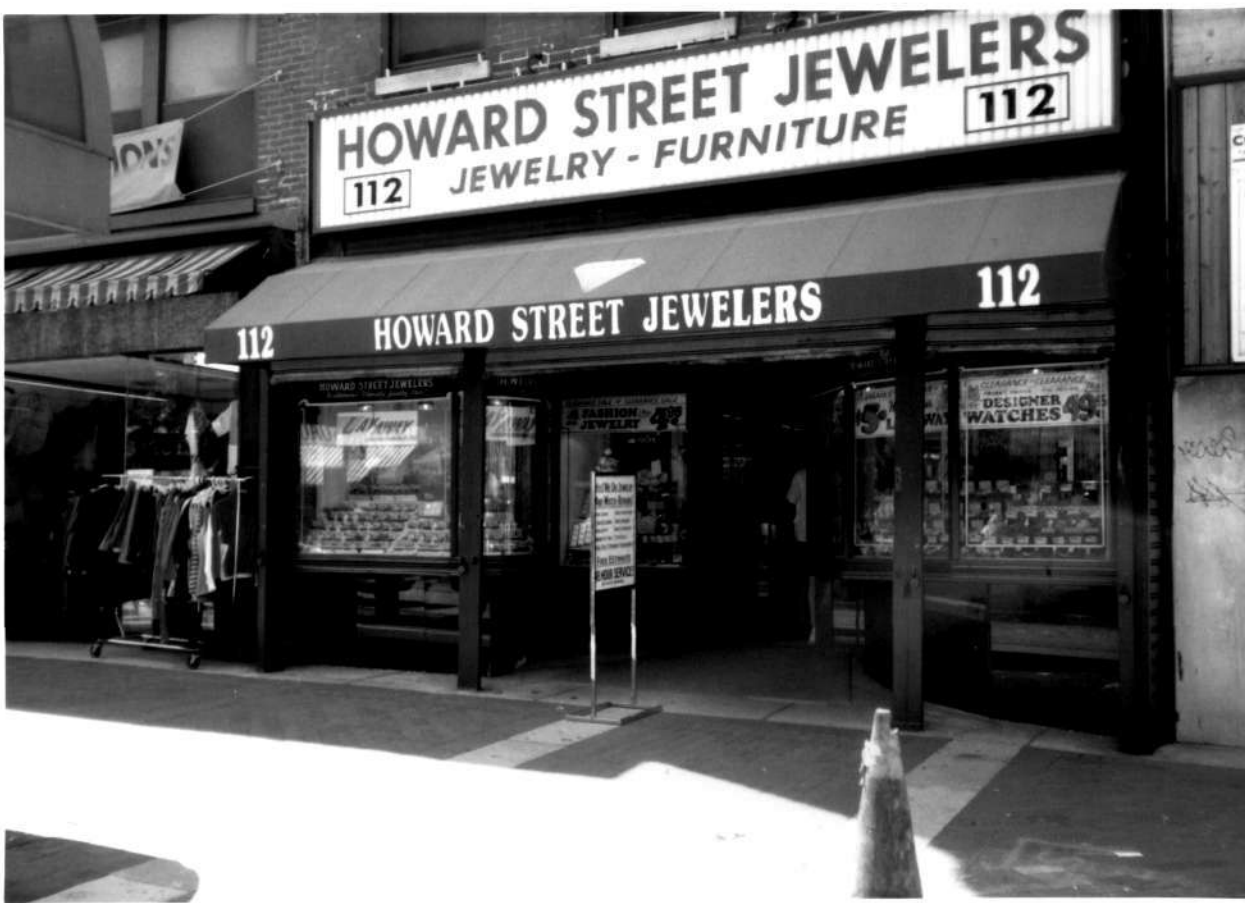
2/3

Facade, detail

The late Art Deco alterations on the first story are an excellent example of a high-style commercial storefront. The recessed facade, typical of the period, is embellished by projecting display cases on raised, ruby vitrolite-faced plinths. The vitrolite panels are typical of the streamlined phase of Art Deco design where the emphasis is on reflective, smooth wall surfaces. In this example, however, the display cases are unlike any others in the commercial district: the bullnosed and polygonal profiles are unique. The circa 1940 first-story facade is representative of one of last periods of commercial vitality for the street.

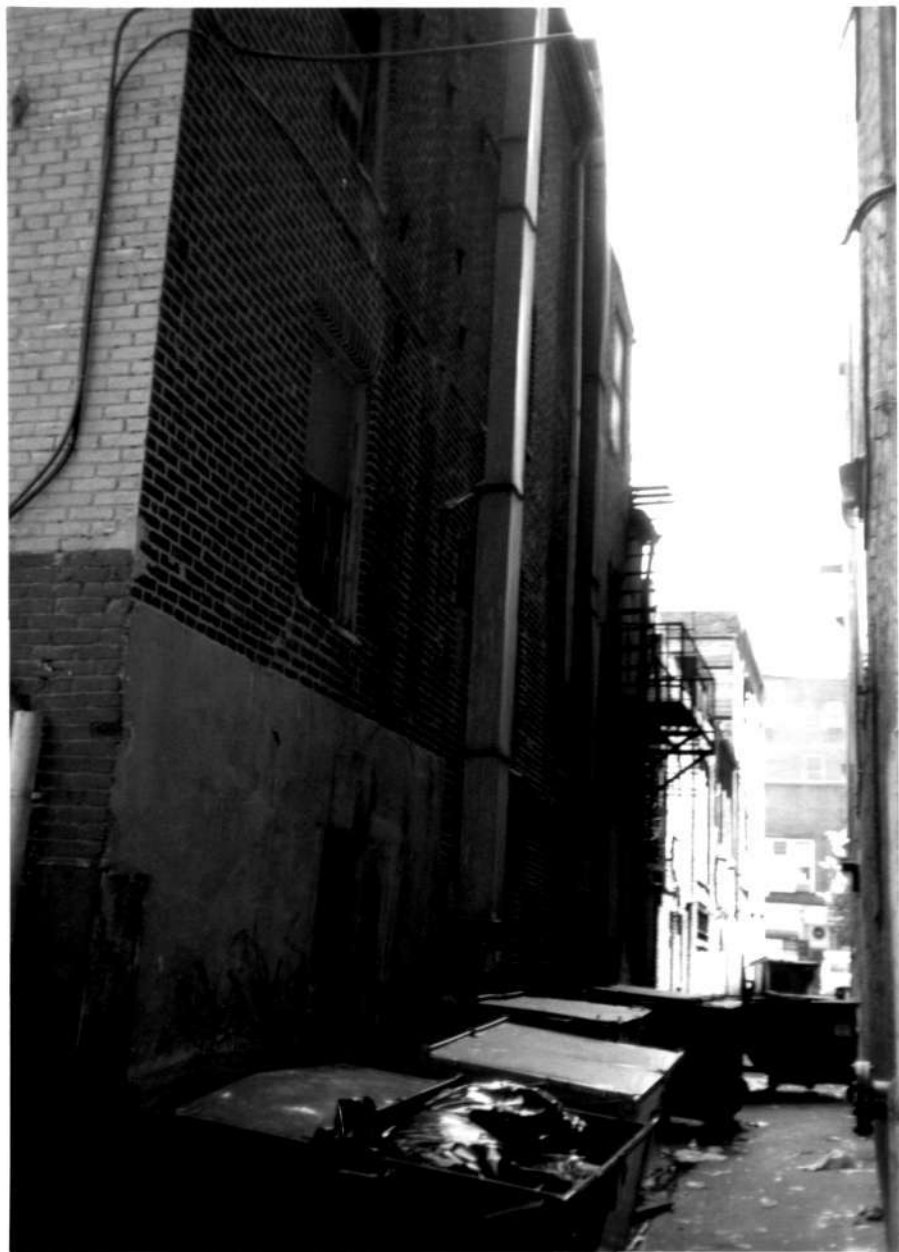
3/3

Rear alley, west elevation
112 in foreground

The west wall faces the alley (State Street). It is three bays wide and only three stories high. The first story has been altered. It contains a new window in the first (north) bay, a new door in the second, and a larger window in the third. All the openings have brick splayed jack arches. The window in the first bay has a sill below; the owner says this was once a water trough and not a door. The second story has a 6/6 sash window in the second bay and a small window in the third. The third story is only two bays wide, with a notched corner obliterating the third bay. A sash window is located off center in the second bay.
